# IR Thermography for the Nondestructive Evaluation of the Protective Coating Coverage on Steel Substrates

**Mohammed Omar and Kozo Saito**  
Dept. of Mechanical Engineering  
University of Kentucky  
Lexington KY 40506-0503

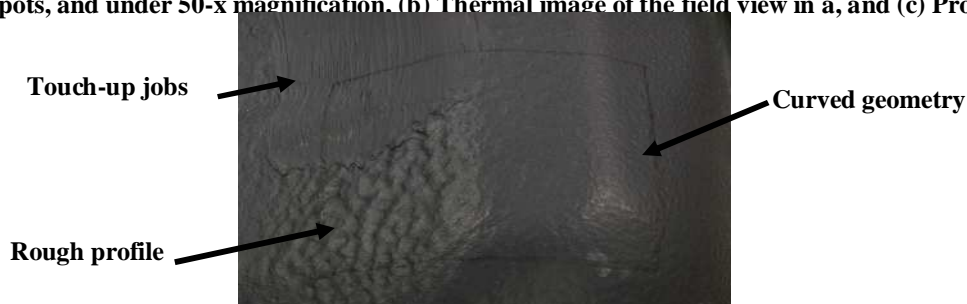
**Figure 2. A color photograph showing surface profile of coated container**

The analytical study and the laboratory testing for this application are fully presented in [2], where a microbolometer infrared detector was used to scan the surface of the tank detecting the difference in thermal emission from the pinholes (behaving according to steel substrate thermal properties) and the well coated surroundings (emitting according to paint properties). This deviation is displayed in figure 2,b and quantitatively described later in the text.

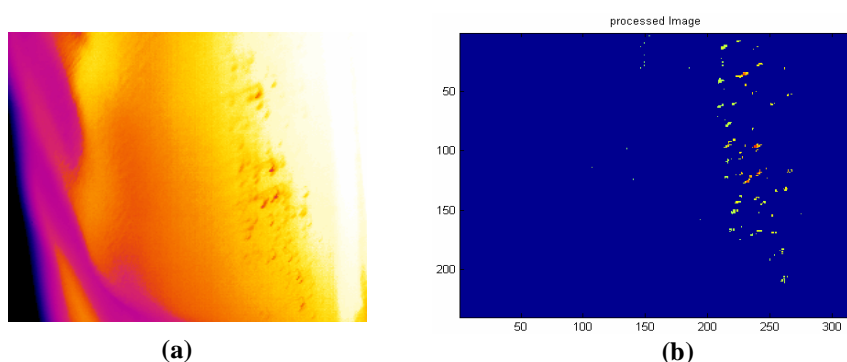
**Figure 3. An on-site test result: (a) Thin coating targets detected at the exit of curing oven, and (b) Corresponding processed thermogram.**

An industrial packaged thermal detector with  $320 \times 240$  array and 60Hz acquisition rate (commercial name A40M, FLIR MA,US) can be installed at the exit of the curing oven. This detector scans the container as it comes out of the oven, and interfaces the acquired thermograms through IEEE1394 link to processing unit. The on-site results are shown in figure 3. The processing logic is discussed in section 4.
